# Acoustic treatment for a radio studio at the Escola Politècnica Superior de Gandia (Polytechnic School of Gandia)

Jesús Alba<sup>1</sup>, Juan C. Rodríguez<sup>1</sup>, Gema González<sup>1</sup>, María Balagué<sup>1</sup>, M<sup>a</sup> Cruz Grau<sup>2</sup>, Ignacio Ramón<sup>2</sup>

<sup>1</sup> Universitat Politècnica de València, Campus de Gandia, Grao de Gandia, Spain  
{jesalba@fis.upv.es, juarodve@upv.es, gegonma@epsg.upv.es, mabagar4@epsg.upv.es}

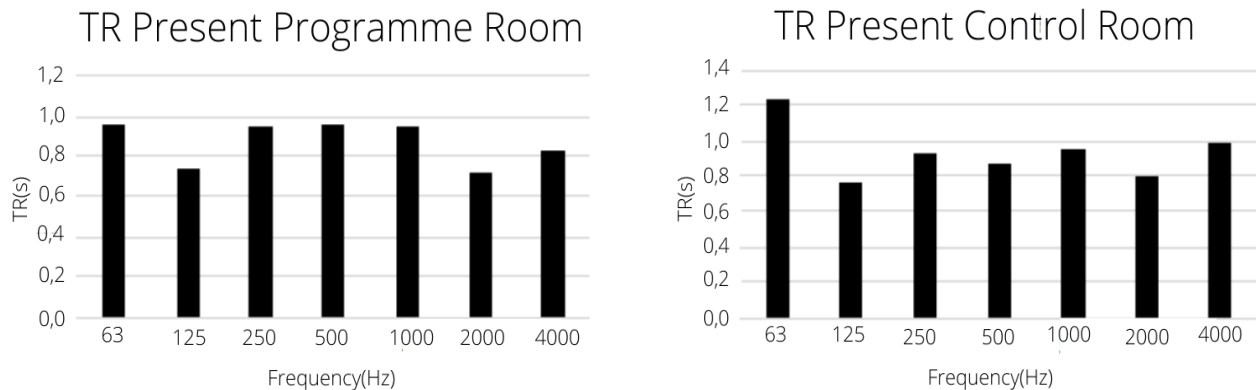
Figure 4 – Reverberation time of the Programme (left) and Control (right) rooms

It can clearly be seen that at low frequencies the reverberation time is very high, therefore, the solution to be investigated has to have a very high absorption coefficient at low frequencies or bass traps for both enclosures. In mid and high frequencies, the TR is also too high, especially in the Studio room. In conclusion, we have two speech enclosures which are not suitable for their purpose. Their major shortcoming is especially the reverberation time. For this reason, a solution has to be found with materials with a very high absorption coefficient.

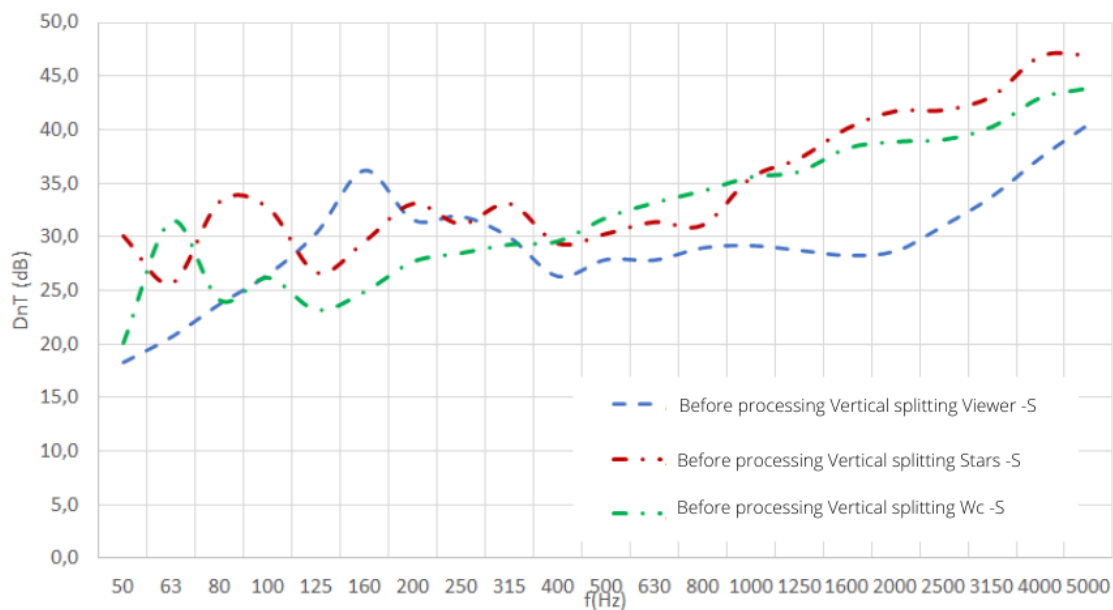
Figure 5 – DnT (dB) of the measured vertical partitions

Figure 5 represents the DnT values per frequency for a detailed visualization. It can be seen how at high frequencies in the vertical partition Stairs (red) and Toilets (blue) reach values close to and above 40 dB, except in the vertical partition Viewer (blue), as a consequence of the viewer containing this wall.

On the other hand, at low and medium frequencies, the three partitions have poor DnT values.

In summary, there is a poor level of sound insulation that allows external noise pollution, as in both rooms there is a surface that faces the façade of the building, in addition to the noise from the machines on the roof. The partition studied in Enclosure 1 overlooks a common area where a large number of people pass through, which is a nuisance for the use of the room. The partition between Enclosure 1 and Enclosure 2, there is noise pollution due to the fact that the wall contains a visor, and this type of gap always breaks with the insulation. And finally, the third partition that separates the toilets from the control room, it is important that it be well insulated as the noise from the toilet cisterns or people should not affect the control room. Consequently, action will be taken to improve the sound insulation of the vertical surface separating the Studio room and the stairs, and also the vertical surface between the toilets and the control room.

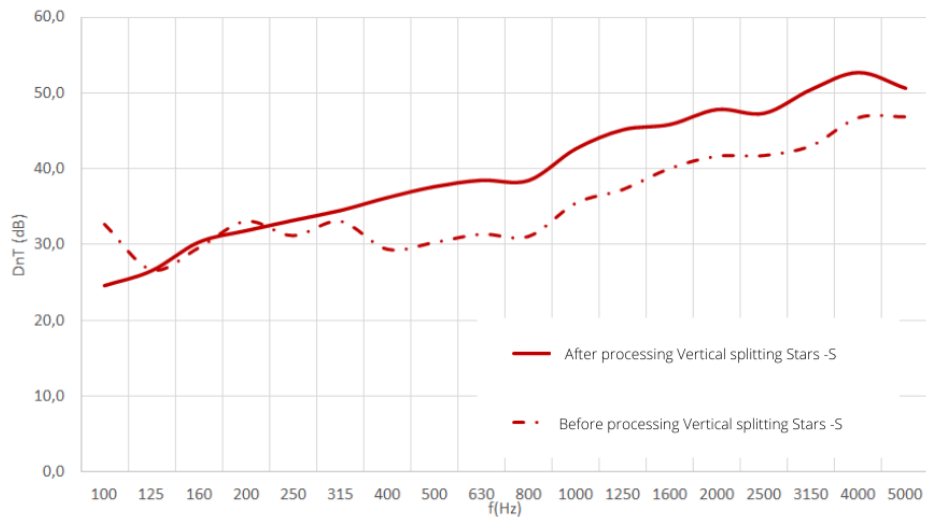
Figure 10 – Insulation of the vertical partition Stairs-Studio Room

Analysing the graph presented in Figure 10, which corresponds to the vertical partition Stairs-Studio Room, it can be affirmed in almost all frequency bands, especially in the medium and high frequencies, the proposed solution improves the acoustic insulation and also, as verified in the previous section, the acoustic conditioning of the room.

Table 6 presents the overall values of the standardised weighted level difference  $DnT,w$  (dB) before and after the acoustic treatment, showing a 6 dB improvement in insulation.

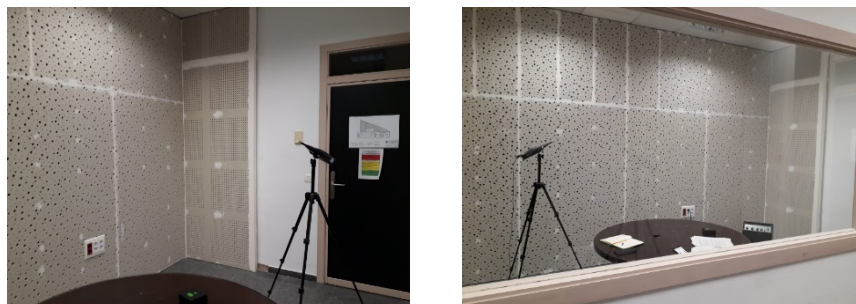
Figure 11 – Images of the Studio Room with the proposed solution installed

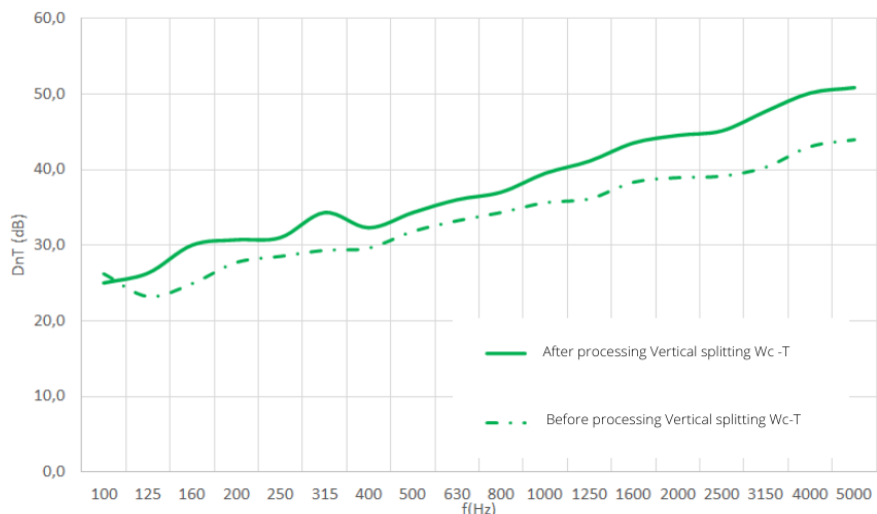
Figure 12 – Insulation of the vertical partition Toilets-Control Room

In Figure 12, the graph corresponding to the vertical partition Toilets-Control Room is presented. It can be seen that the proposed solution improves the acoustic insulation in almost every frequency band.

In this case, the insulation improvement is lower than in the previous one, as there is less surface area to be applied. As presented in Table 7, there is an improvement of almost 4 dB of improvement after applying the acoustic treatment.

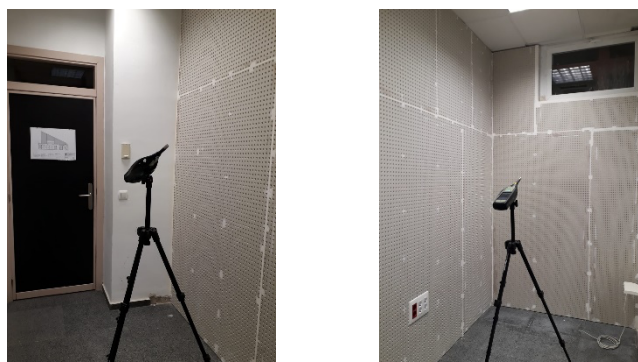
Figure 13 – Control room with the proposed solution installed
