The acoustic characteristics of heritage theaters in Quito-Ecuador

Ernesto Ochoa, Antonio Pedrero, M^a de los Ángeles Navacerrada

Abstract

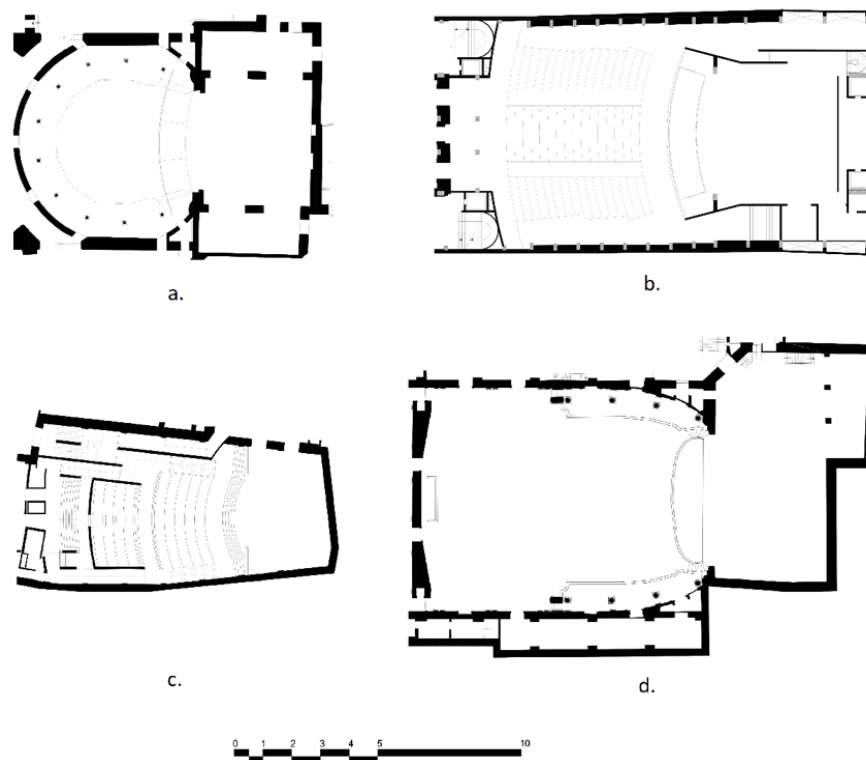
Figure 1- Plan graph of the theaters studied, in their current state.

Theaters	Hall Volume m ³	Max. Dim. M (LxWxH)	Audience area m ²	Number of seats
a. Sucre	3283,03	15,17 x 20,02 x 10,81	303,70	795
b. Capitol	8953,70	19,20 x 23,66 x 19,71	454,27	850
c. Variedades	1930,38	09,40 x 13,60 x 15,10	127,84	250
d. Bolívar	9055,94	27,48 x 22,51 x 14,64	618,57	2200

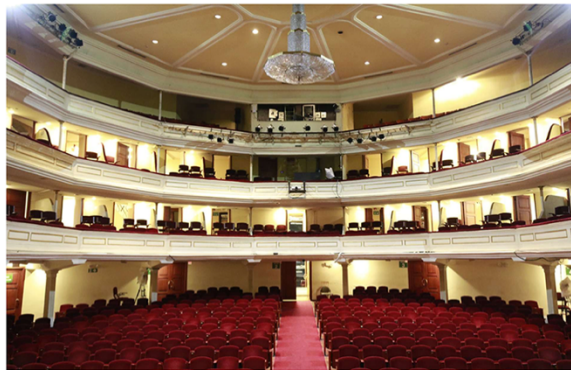
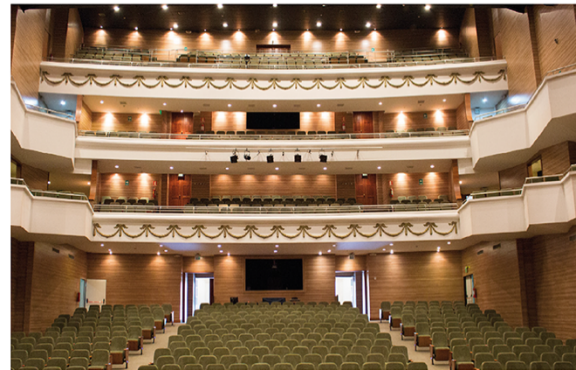
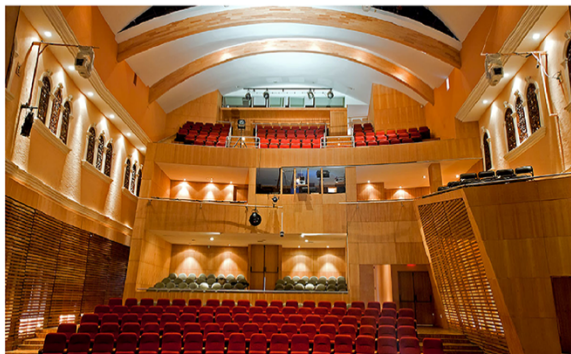
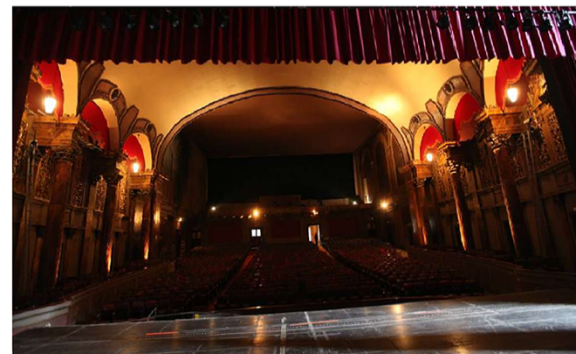
Figure 2- Interior view of the theaters studied, in their current state.

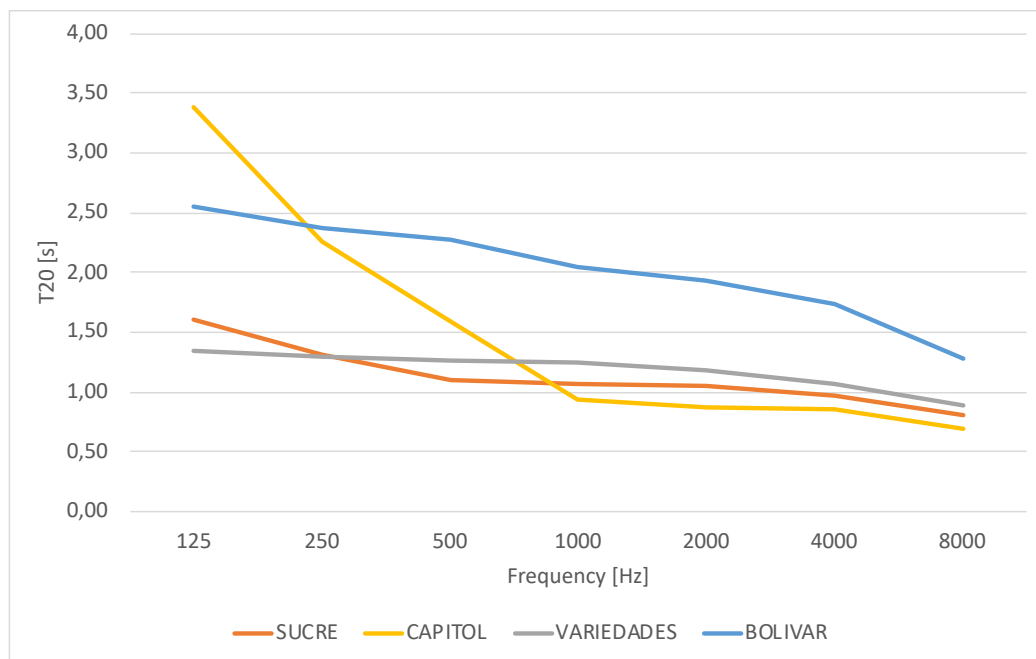
The results of the measurements show marked differences between the acoustic characteristics of the different theaters studied. Attending, in first instance, to the reverberation time, we can identify two theaters (Sucre and Variedades) with T_{20} values that oscillate, approximately, between 1s and 1.5s in all frequency bands, which a priori makes them appropriate for applications where correct intelligibility of the spoken signal is important. At the opposite extreme is the Bolívar Theater, with significantly higher reverberation times. Finally, the Capitol Theater presents an unusual frequency distribution of reverberation times. While in mid and high frequencies the T_{20} values are lower than those of any of the other theaters, below the 1kHz band there is a gradual increase in the T_{20} values that can exceed 3 s in the 125 Hz. All this can be seen clearly in figure 5.

Figure 5 - Comparison of T_{20} values as a function of frequency for the theaters studied.

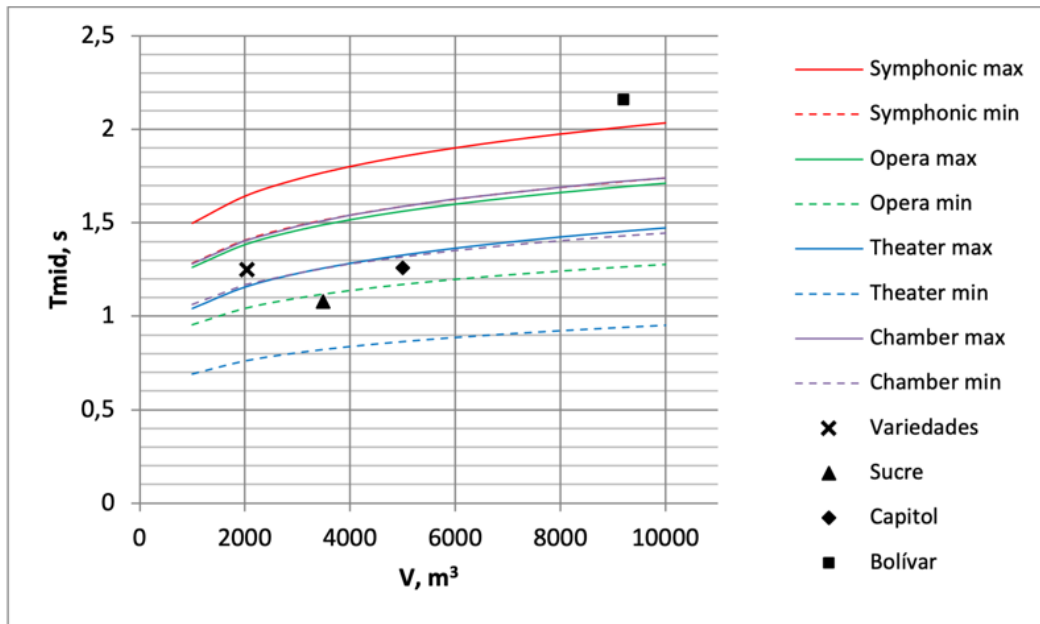
As a representative example of these evaluations, Figure 6 shows the comparison of the reverberation times at mid frequencies measured in the different theaters, with the optimal reverberation times, as a function of volume, for the different possible uses.

Figure 6 - $T_{20 \text{ mid}}$ values of the studied theaters compared with the optimal reverberation time values according to Arau [8].

The comparison of the values of the acoustic parameters obtained in the measurements and the optimal values for each type of use indicates that the Bolívar Theater presents adequate acoustic characteristics for symphonic music. The Sucre theater shows ideal conditions for applications where the signal emitted is the voice, both spoken (theater, conferences, etc.), and sung (opera). The Variedades Theater is shown as a multipurpose room, in which both musical and spoken voice activities can be programmed. With respect to the Capitol theater, the irregularity of the acoustic behavior in the different frequency bands means that its acoustic characteristics do not fully fit in with any of the usual applications of this type of theater.
